**MARKET/FORGE
URBAN RENEWAL AREA
ELIGIBILITY REPORT
AND
URBAN RENEWAL PLAN**

City of Akron, Ohio

Department of Planning and Urban Development

May 2002

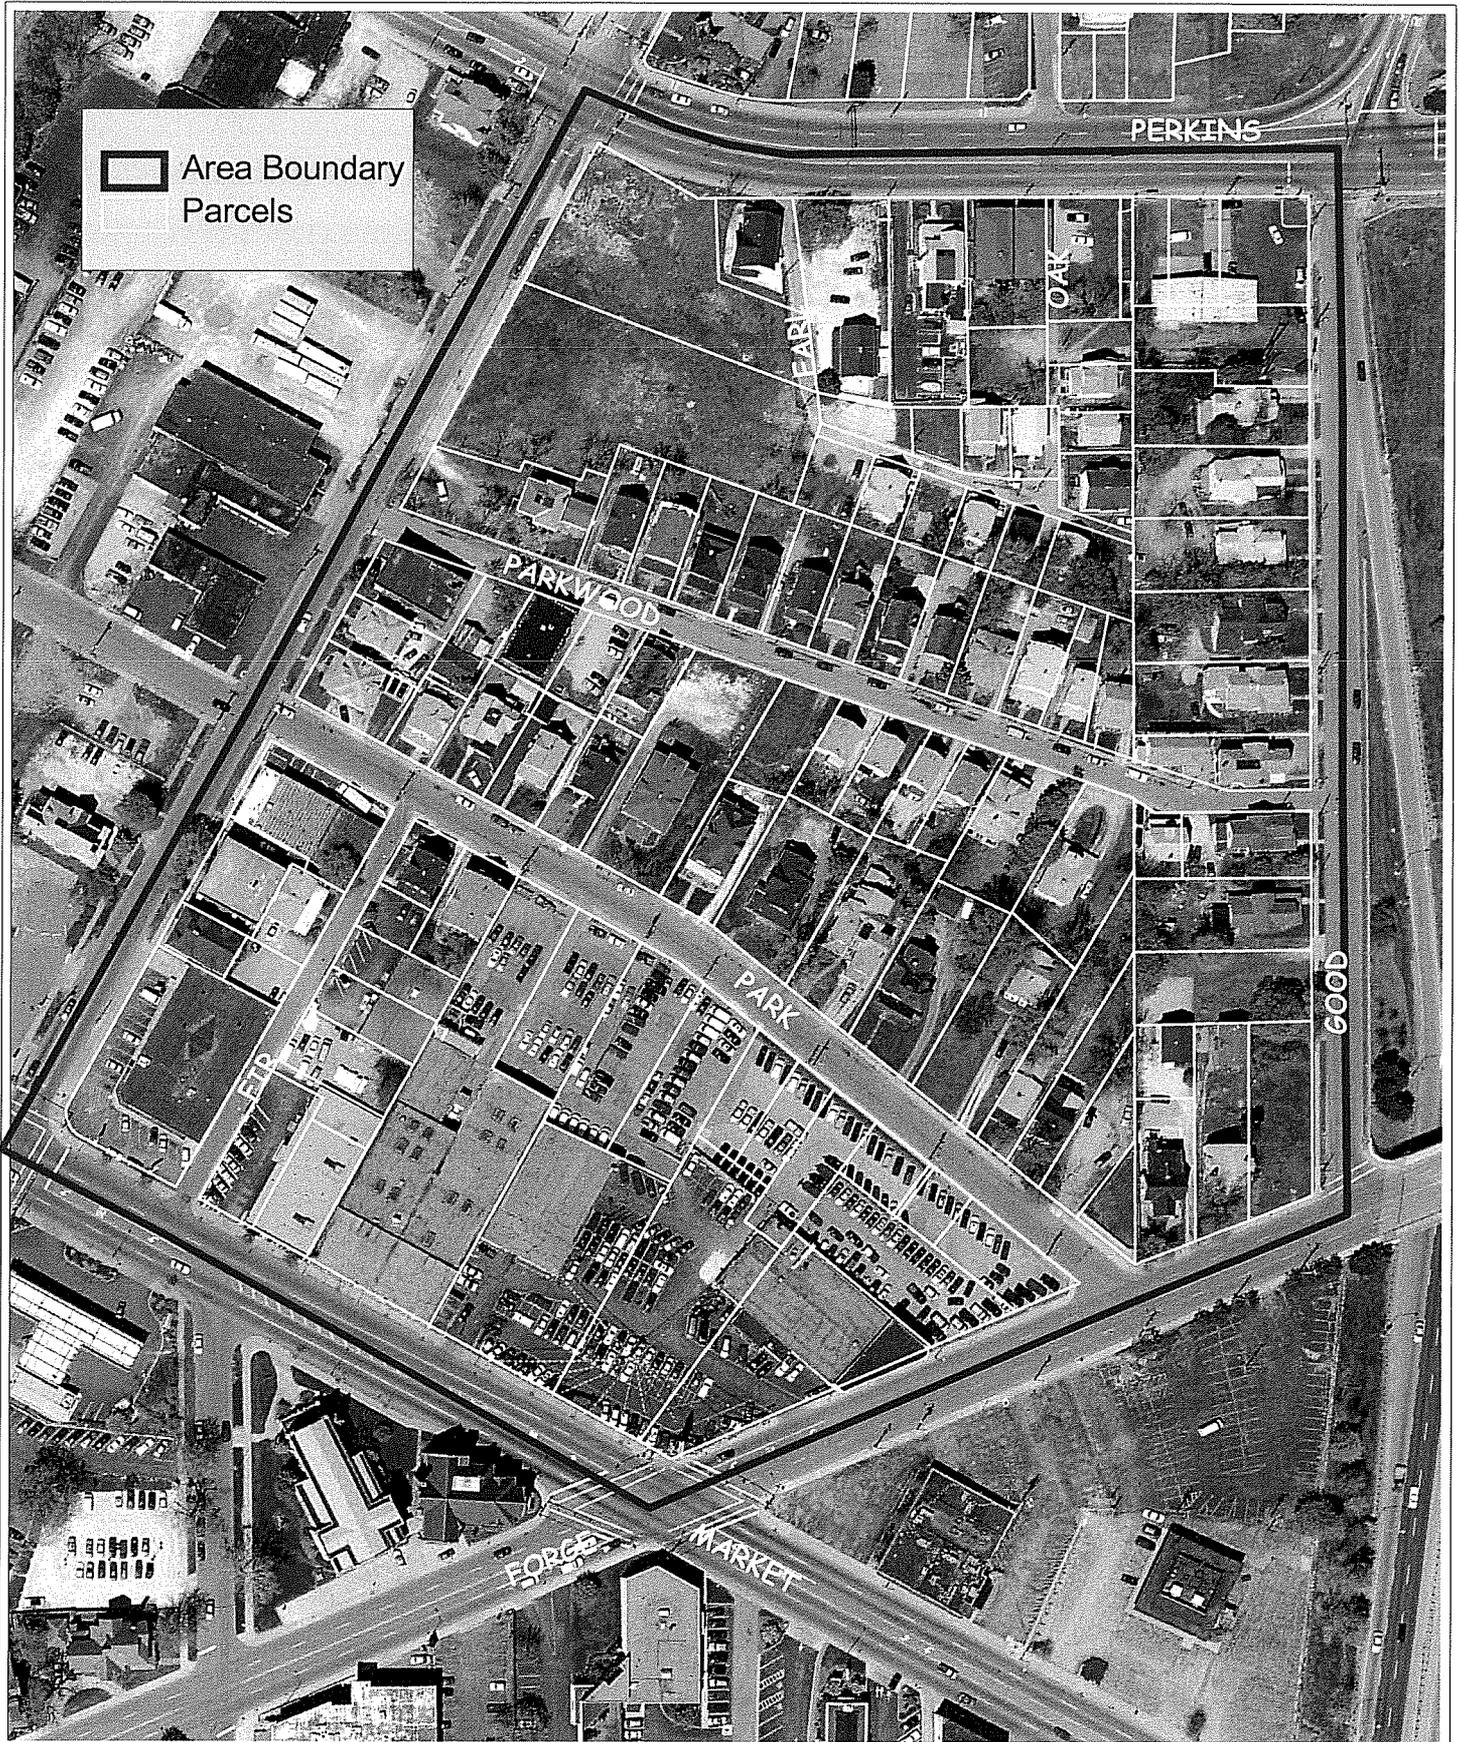
Exhibit 5
Market-Forge Urban Renewal Area
Aerial View

Parking conditions within the Study Area are inadequate for existing uses and evidence lack of space and unmanaged growth. Specific parking conditions will be identified under Other Blighting Influences. Aerial photos of the area (Exhibits 5 and 5A) show the extent of parking within the Study Area.
