MARKET-MAPLE

**URBAN RENEWAL
AREA ELIGIBILITY REPORT
AND URBAN RENEWAL
PLAN**

City of Akron, Ohio

November 2000

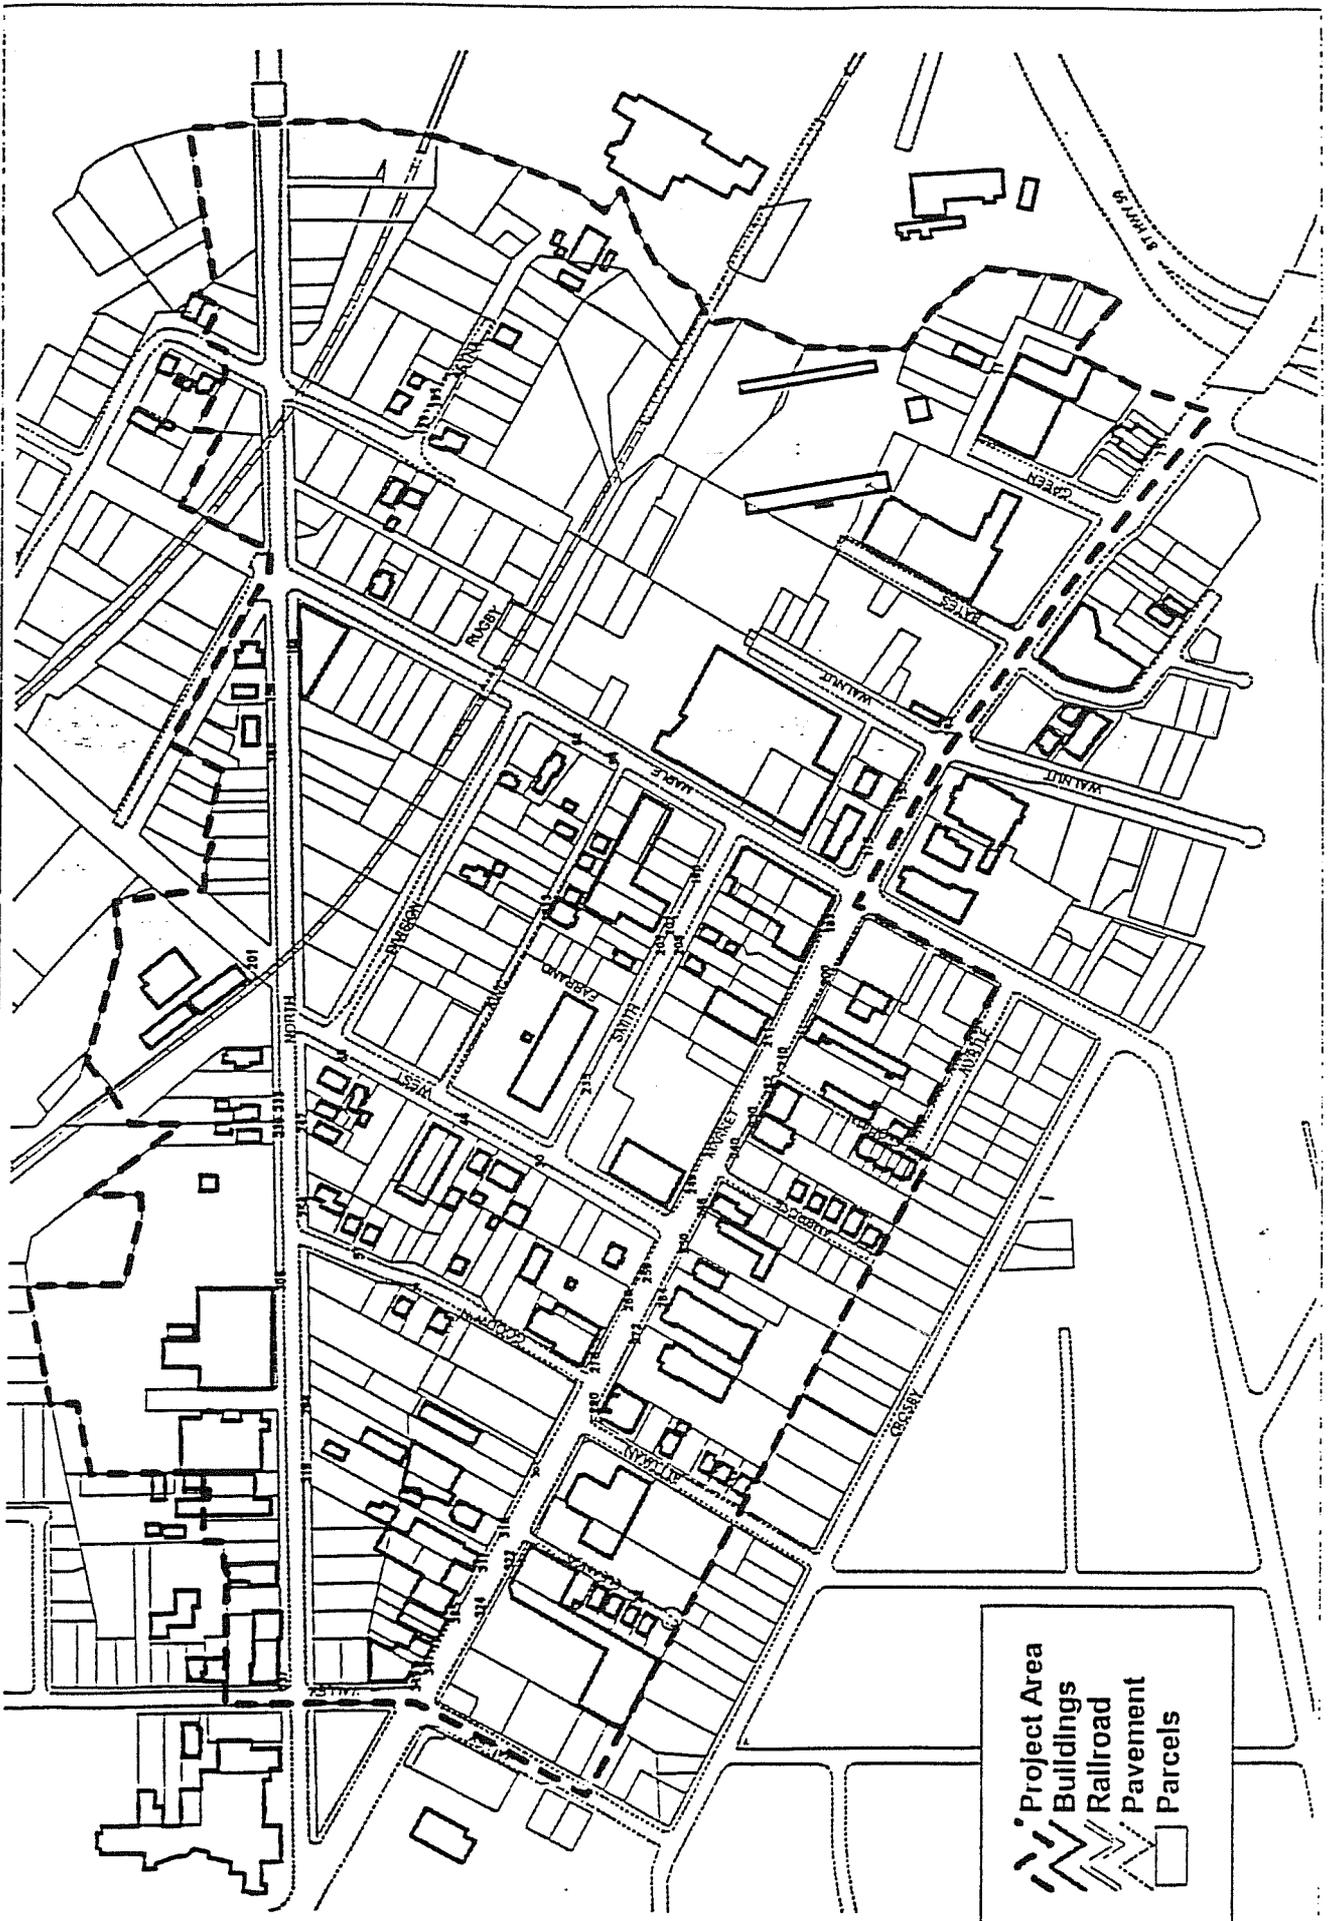
Map 2
Market-Maple Urban Renewal Area
Area Boundary

Project Area
Buildings
Railroad
Pavement
Parcels

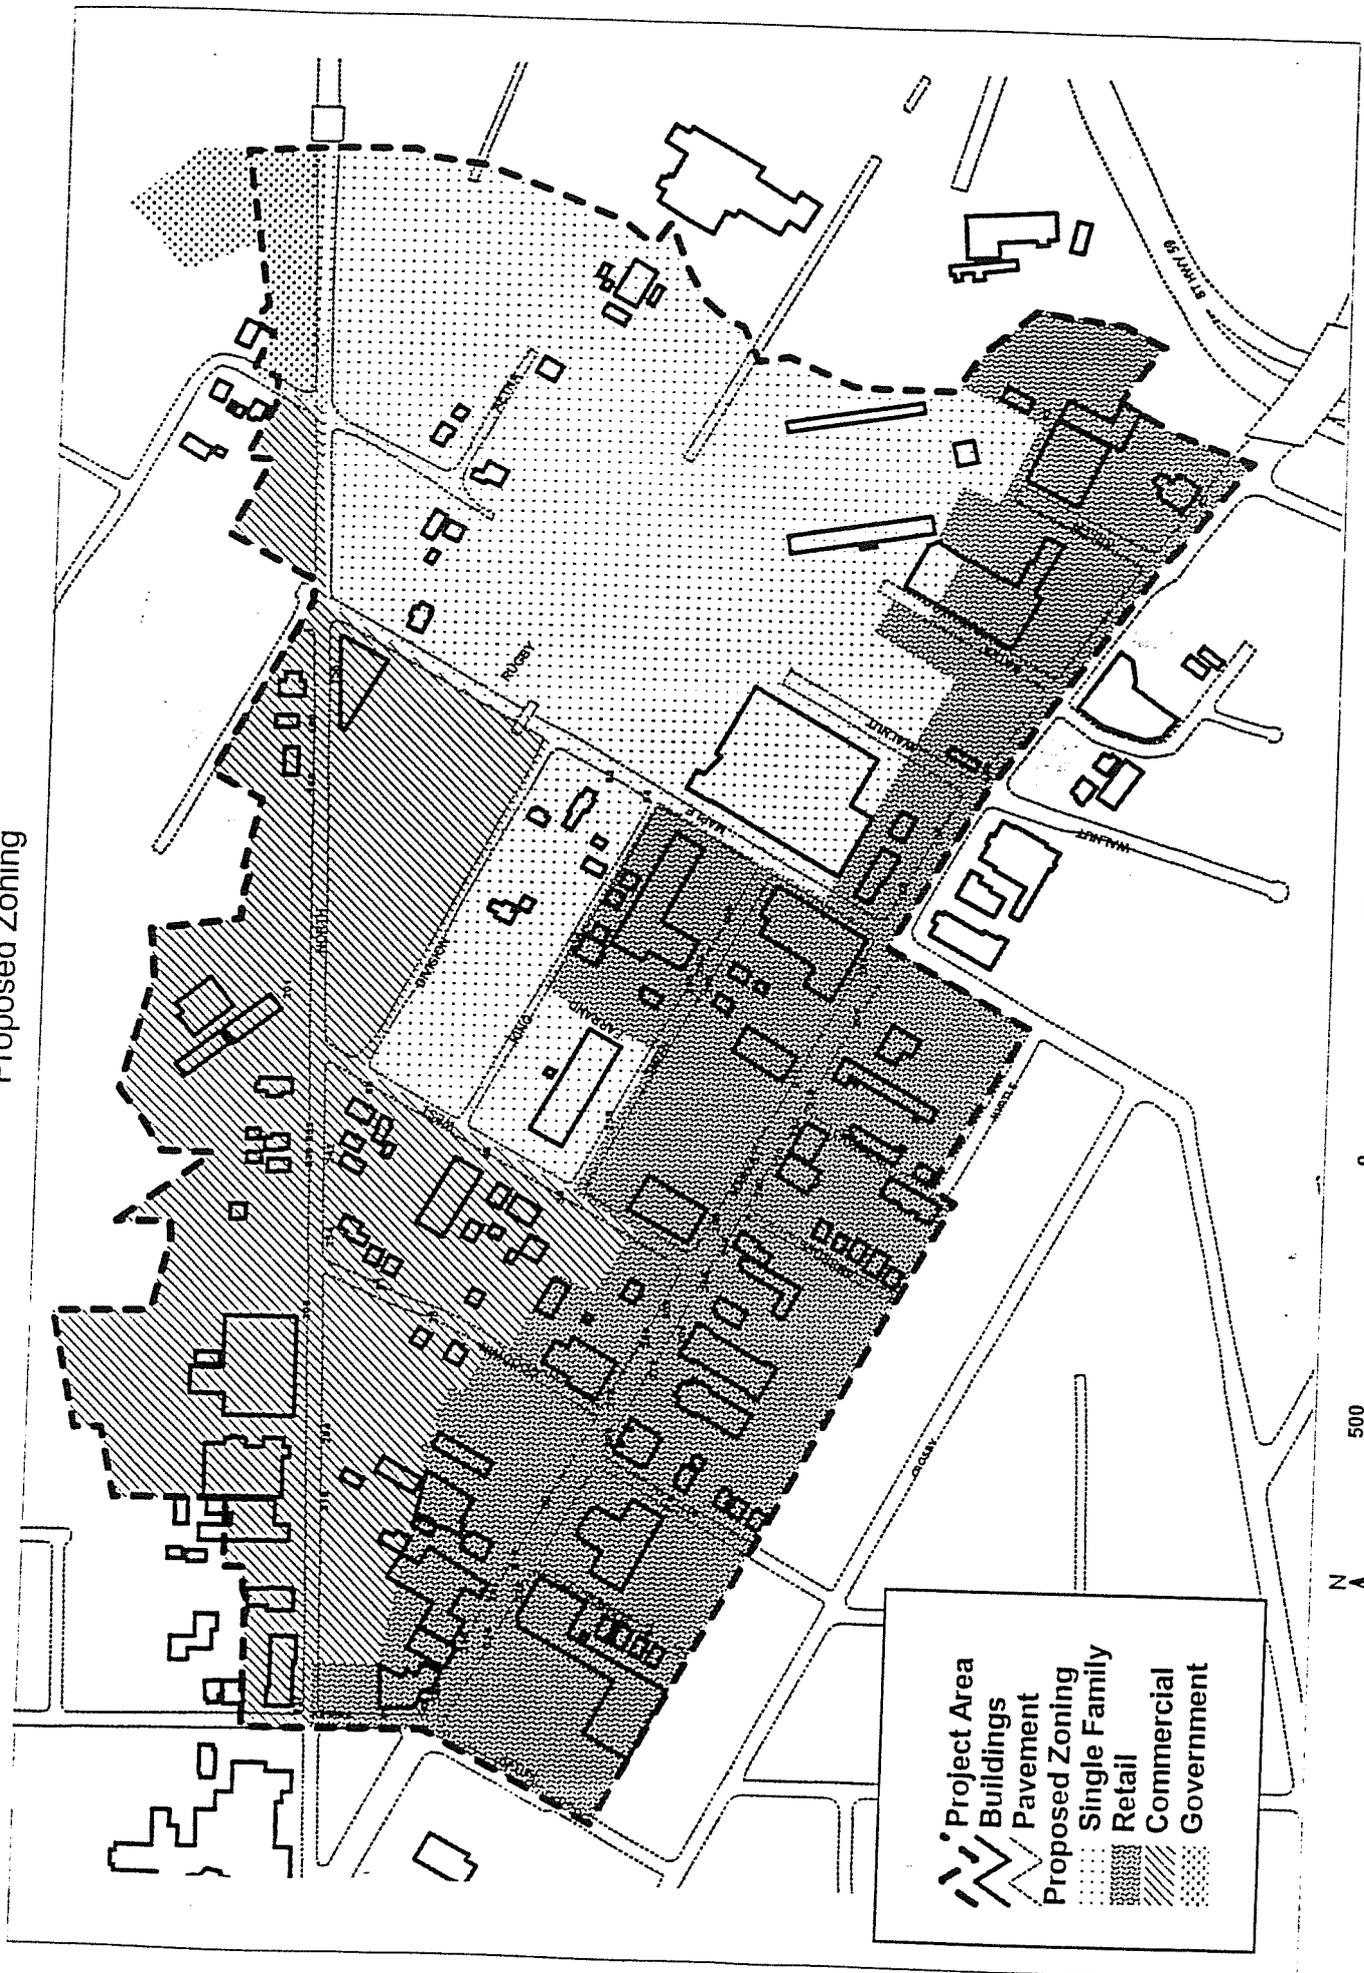
Map 5
 Market-Maple Urban Renewal Area
 Proposed Zoning

Project Area
	Buildings
	Pavement
	Proposed Zoning
	Single Family
	Retail
	Commercial
	Government

It is proposed that the area be zoned Dwelling District (U1), Retail (U3), Commercial (U4), and Government (UG), as found in Chapters 153.101, 153.106, 153.107, and 153.108 of the Akron Zoning Code and as indicated on Map 5. Changes in zoning are indicated on Map 6.

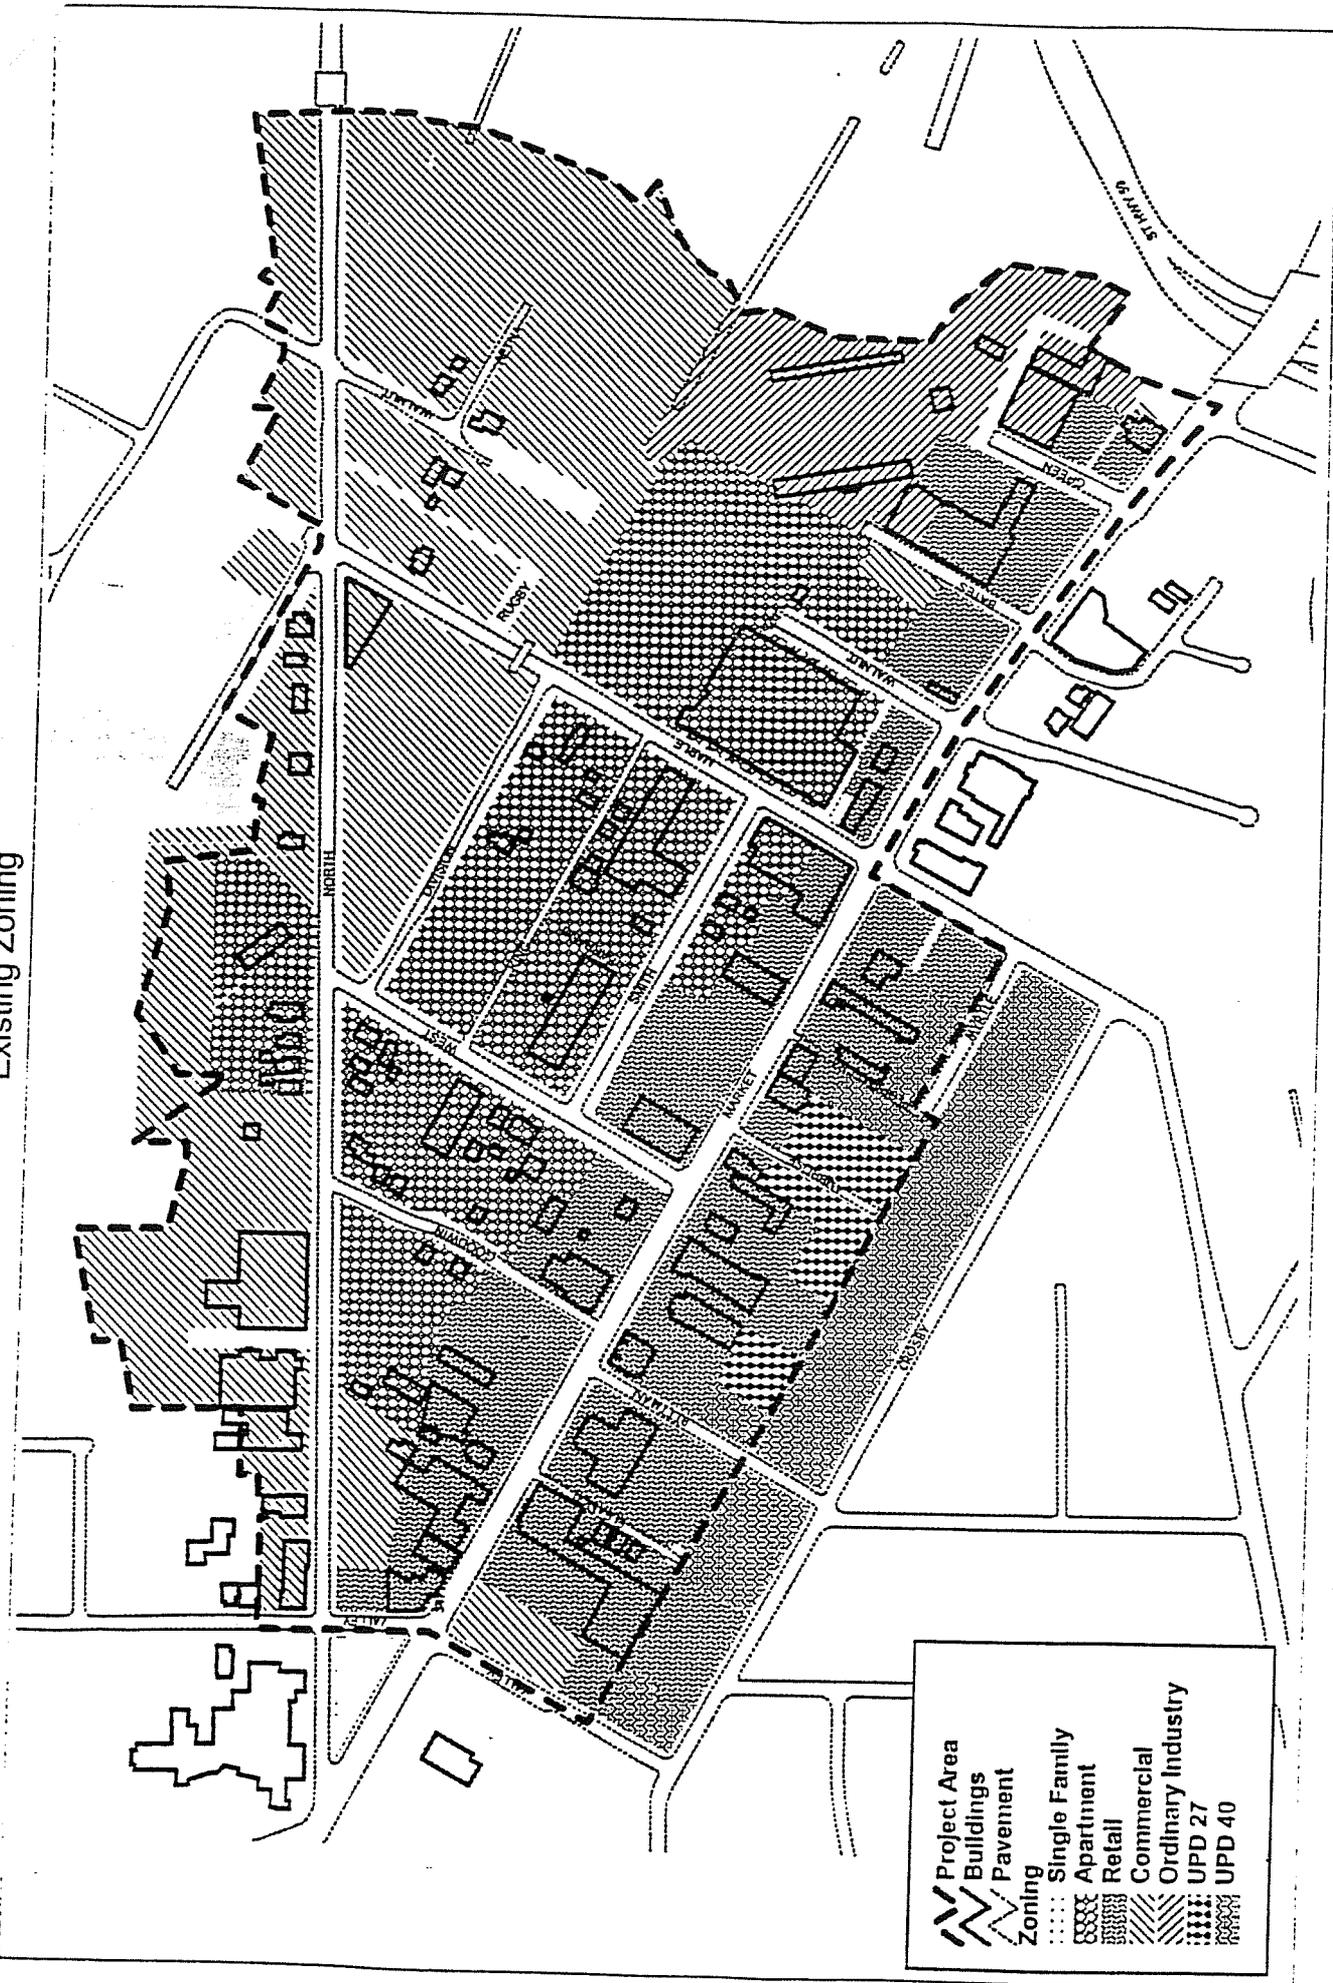
Map 3
Market-Maple Urban Renewal Area
 Existing Zoning

- Project Area
- Buildings
- Pavement
- Zoning
- Single Family
- Apartment
- Retail
- Commercial
- Ordinary Industry
- UPD 27
- UPD 40

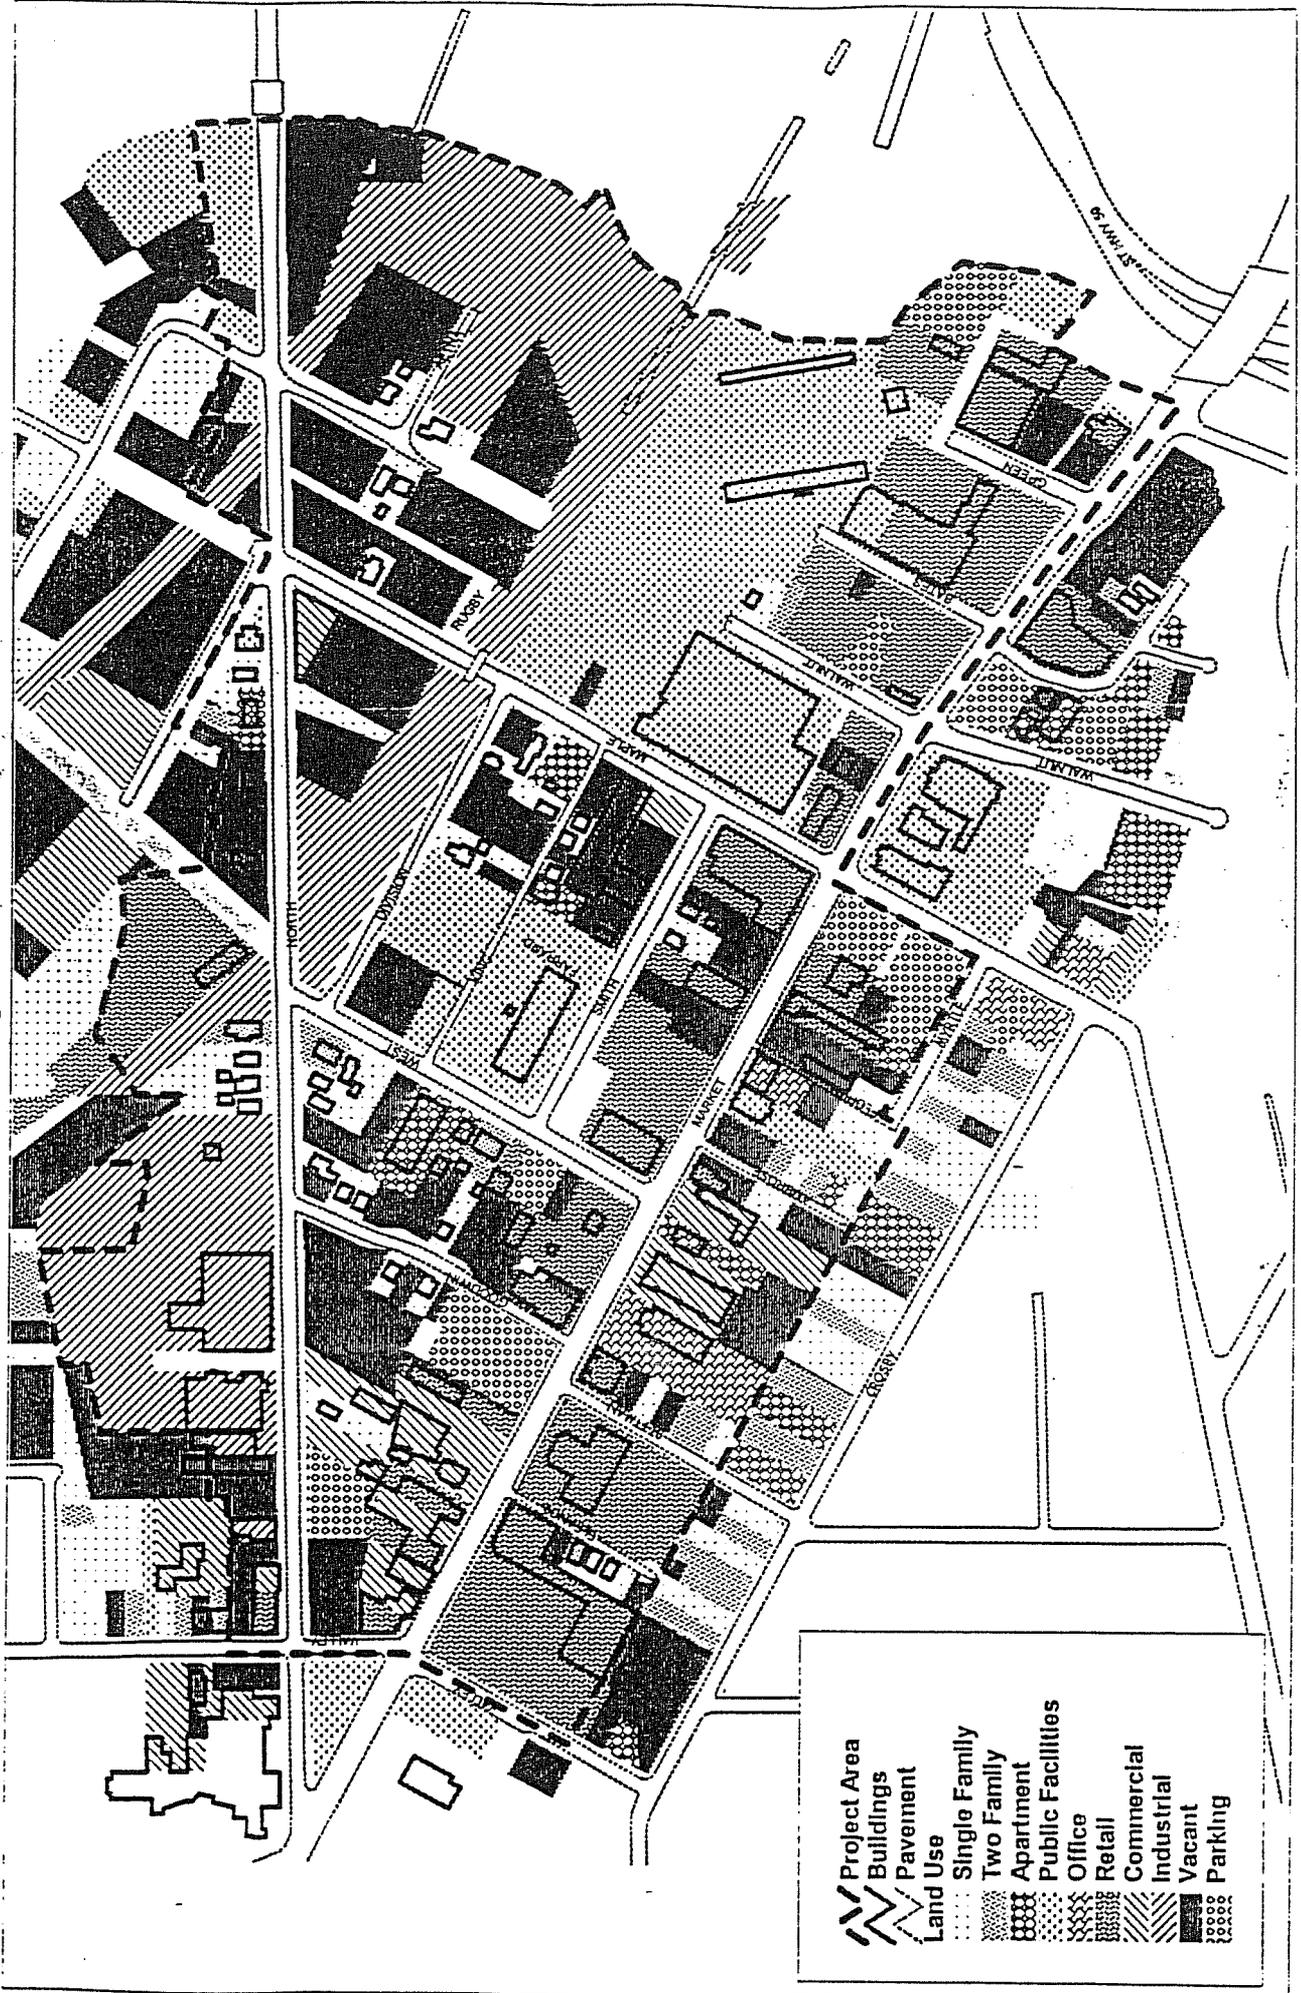
Map 4
 Market-Maple Urban Renewal Area
 Existing Land Use

- Project Area
- Buildings
- Pavement
- Land Use
- Single Family
- Two Family
- Apartment
- Public Facilities
- Office
- Retail
- Commercial
- Industrial
- Vacant
- Parking
